Cylinders troubleshooting

The following sections provide guidelines for the common cylinders failures with a simple scheme driving through the analysis of causes and preventive actions to avoid premature breakdowns. The last section gives useful information about the main spare parts codes necessary to proceed with a complete cylinder's mechanical overhaul.

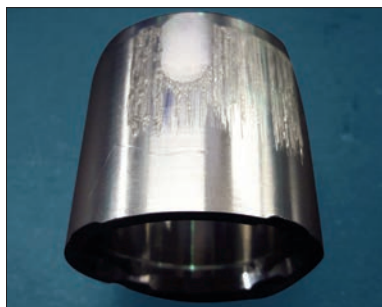
2 FLUID CONTAMINANTS

Trouble description: contaminated fluid is one of the main causes of seal leakages. Abrasive particle contamination is evidenced by scratch and score marks on the seals, rod bearing and cushioning piston with consequent leakages and loss of cushioning effect which place the cylinder out of service.

Action & prevention: hydraulic circuit must be provided with appropriate filters (at least 25 µm) to grant a contamination class lower than ISO 19/18/15 according to ISO 4406. Take care to grant adequate recirculation of the oil flow.

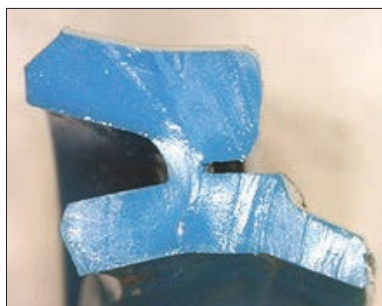
3 OVERPRESSURE

Trouble description: excessive flow restriction in the hydraulic circuit or mechanical rod shocks could involve peaks of pressure which stress rod seals and give rise to rapid seal wear and leakages. The seals appears with abnormal wear and, in the worst cases, extruded.

Action & prevention: hydraulic circuit must be designed to avoid flow restrictions which could involve dangerous peaks of pressure. A PTFE sealing system **G2-G4-G8** should be preferred if the peaks of pressure cannot be reduced, contact Atos technical office.

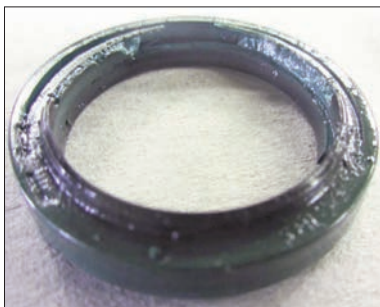
4 UNSUITABLE FLUID

Trouble description: presence of aggressive additives in the fluid is one of the main causes of seals compound deterioration that causing heavy leakages. Seals may appear sticky or dry depending to the chemical reaction.

Action & prevention: the correct choice of sealing system according to the fluids is the main prevention. Atos technical tables provides the seals compatibility with the most common fluids, for water based fluids (HFA, HFB, HFC) or synthetic HFD-U PTFE seals **G2-G4** are mandatory, in particular for phosphate esters HFD-R PTFE seals **G2** must be selected. In case of special fluids not indicated in Cylinder's technical table please contact Atos technical office to receive suggestions on the most suitable seals for your application.

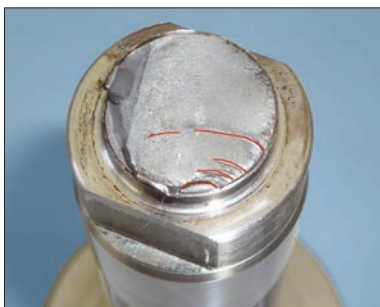
8 HIGH PRESSURE / LOADS

Trouble description: overpressures/overloads respect to cylinders limits or high loads/pressures coupled to high frequency applications or long life expectations may involve mechanical failures of the rod thread, that is the most critical part of any hydraulic cylinder. In the first case a ductile failure may result, the rod end presents a necking area followed by a tear break zone; in the second one a fatigue failure may occur, the breaking of the rod thread is featured by an early progression of serious brittle cracks (see red line in the picture) with final plastic yielding.

Action & prevention: in case of ductile failure check the compliance of actual pressures/loads with the cylinder's max operating pressure shown in relevant technical table. In case of fatigue failure check the fatigue life expectation in accordance with the instructions given in tech. table **B015**. If above checks highlight conforming application data please contact Atos technical office.
